# Mobile Intel<sup>®</sup> Pentium<sup>®</sup> 4 Processor-M

## Specification Update

*September 2004*

Document Number: 250721-025

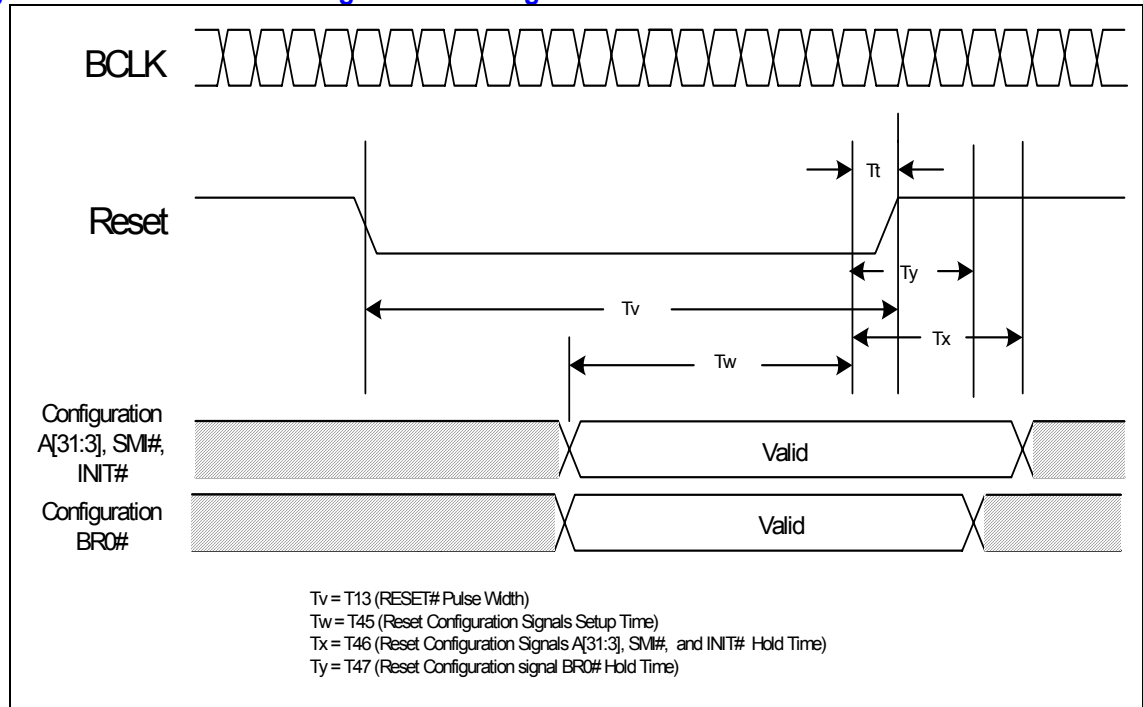
**Figure 13. System Bus Reset and Configuration Timings**

The BR0# maximum hold time has changed to 2 BCLKs. This change will be shown in the “System Bus AC Specifications (Reset Conditions)” table and “System Bus Reset and Configuration Timings” figure of the *Mobile Intel® Pentium® 4 Processor - M Datasheet*. This change will be incorporated in the next revision of the datasheet.

The following figure will be modified to reflect this change:
