# Mobile Intel® Celeron® Processor on .13 Micron Process in Micro- FCPGA Package

Specification Update

*September 2004*

Document Number: 251309-022

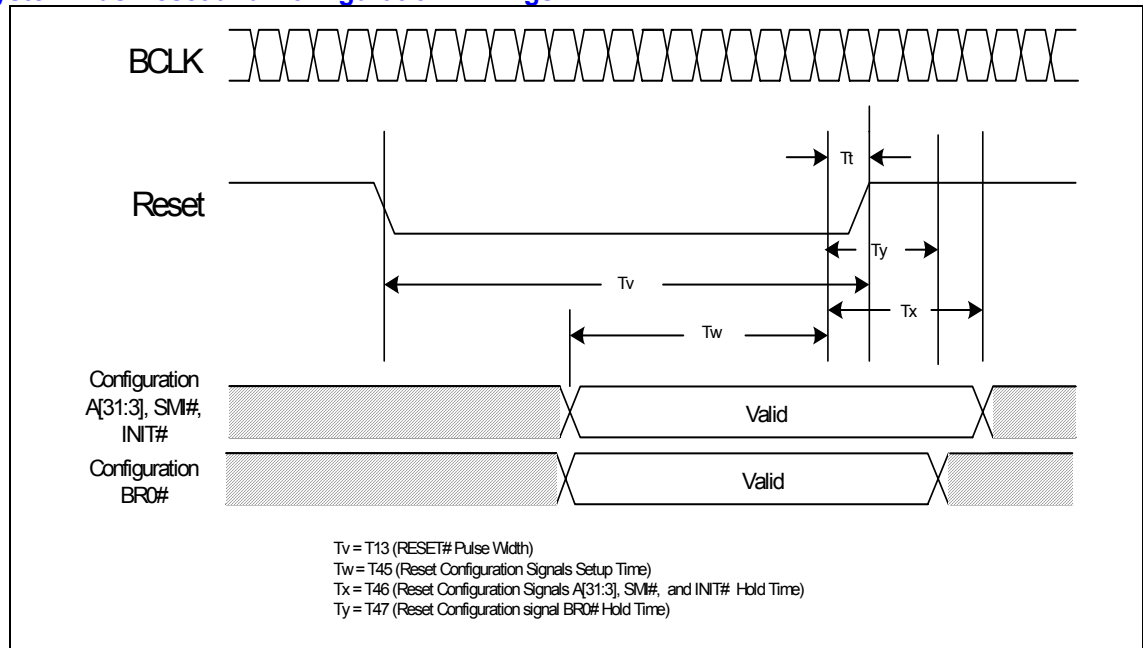
**Figure 12. System Bus Reset and Configuration Timings**

The BR0# maximum hold time has changed to 2 BCLKs. This change will be shown in the “System Bus AC Specifications (Reset Conditions)” table and “System Bus Reset and Configuration Timings” figure of the *Mobile Intel® Celeron® Processor on .13 Micron Process in Micro-FCPGA Package Datasheet*. This change will be incorporated in the next revision of the datasheet.

The following figure is modified to reflect this change:
